# An Experimental Analysis to Determine the Load-Bearing Capacity of 3D Printed Metals

**Abstract:** Reverse engineering is conducted based on the analysis of an already existing product. The results of such an analysis can be used to improve the functioning of the product or develop new organizational, economic, information technology, and other solutions that increase the efficiency of the entire business system, in particular 3D printed products. Therefore, the main aim of this research is to focus on evaluation of the load-bearing capacity of already existing 3D printed metals in order to see their suitability for the intended application and to obtain their relevant mechanical properties. To this end, 3D printed metallic bars with almost square cross-sections were acquired from an external company in China without any known processing parameters, apart from the assumption that specimens No. 1–3 are printed horizontally, and specimens No. 4–7 are printed vertically. Various experiments were conducted to study microstructural characteristics and mechanical properties of 3D printed metals. It was observed that specimens No. 1–6, were almost similar in hardness, while specimen No

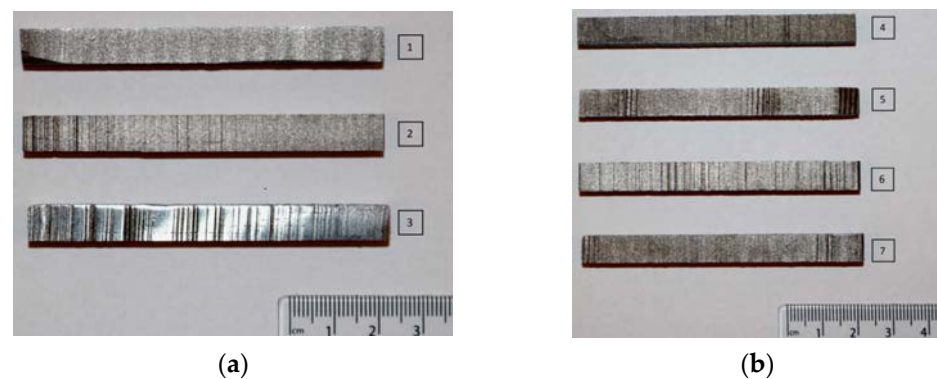
**Figure 2.** The 3D printed metallic bars: (a) sample No. 1–3 were printed horizontally and (b) sample No. 4–7 were printed vertically.

Three-dimensionally-printed metallic bars with almost square cross-section were acquired from an external company in China, without any known processing parameters apart from the assumption that three of them are printed horizontally as shown in Figure 2a, and four of them printed vertically as shown in Figure 2b. From this figure, surface of the samples is uneven, and this indicates that the samples are fabricated directly from the 3D printers without any post-processing such as surface finishing. Therefore, dimensions were initially measured (Table 1), which is 80 cm long and close to 8 mm wide and thick.

The primary inspection showed that there were signs of incomplete printing or damage during the removal of the specimens from the substrate (samples No.1 and 5, where the ends of the samples are missing material). Although the sample surfaces were very rough, a quick analysis also depicted signs of lack of fusion (e.g., in sample No. 3, there are horizontal lines of lack of fusion from the middle towards the right side of the specimen (see dotted lines)). No further defects were seen or identified at this stage. Moreover, the magnetic properties of the samples were investigated, as this property is a good indicator of the chemical composition of the metal. The results showed that all samples are magnetic. Accordingly, it was assumed that they are ferromagnetic (ferritic microstructure), thus the

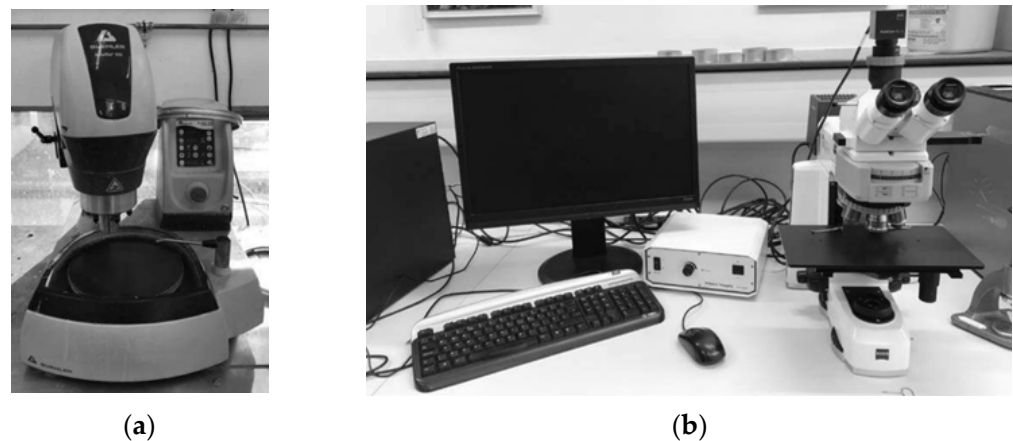
**Figure 3.** (a) Buehler Automet 250 Utilized for grinding and polishing processes throughout the experimental phases. (b) Zeiss Lens Microscope utilized in the current research with the magnification levels of  $2.5\times$  to  $100\times$ .

The SLM printed bars were acquired with no processing information; thus, extra steps were necessary before moving onto the various testing phases. For example, it is important to reduce surface roughness for performing any hardness tests, initial microscopy, and EDX spectroscopy alongside the SEM. In other words, the level of surface roughness plays a major role in the results of these tests and can affect the interpretation of the results. To this end, Buehler Automet 250 polishing machine and sandpaper with various grit sizes (P80–P4000, according to ISO standard) were used. Figure 3a demonstrates the machine utilized to obtain a polished surface for further analysis in this study. The cooling system of this device works with water. Moreover, its rotation speed is also adjustable. Further polishing was also possible using the current equipment but was not required at this step as the sandpaper alone revealed most of the defects. After polishing, the sample sizes were measured again, as these parameters are required for subsequent calculations and references. However, due to the small thickness of the samples, direct polishing was not possible, and the sample could not be guided by hand. To overcome this problem, ATM OPAL 410 resin mounting machine was used to prepare the sample. Thus, Bakelite resin was employed and the hot step for melting the resin was performed at 200 °C for 3 min. After that, the liquid resin was hardened by cooling circulating water for 3 min. Next, to appear the microstructure, according to the results of chemical composition analysis (detection of stainless steel and high percentage of chromium in the material), Kalling solution was used. This etching reagent contains 2 g Copper Chloride, 60 mL Methanol, 20 mL Water, and 40 mL Hydrochloric Acid. The action of this solution on the target metal caused to darken of ferrite and martensite phases [38]. A Zeiss Lens microscope was utilized to identify and assess the microstructural defects expanded in the previous section, including lack of fusion, porosity, cracks, and layer delamination. In addition, AxioVision software package was employed to analyze images. Figure 3b illustrates the equipment facilities used in this part of the research. This software had many features such as being able to adjust the contrast, brightness, etc., as standard and the most useful feature was the panoramic image acquisition. This allowed for entire surfaces to be documented at higher magnification levels which would make the analysis of these surfaces easier.

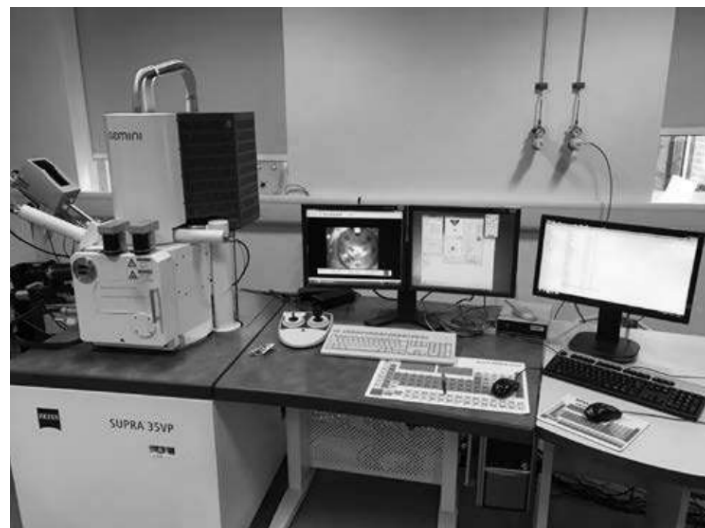
**Figure 4.** Zeiss SUPRA 35VP SEM alongside the central console utilized in the current research.

SEM observations were performed using SUPRA 35 VP (Carl Zeiss, Jena, Germany) with Inca 400 facilities for a more detailed study of the defects identified in the previous step. Figure 4 displays the set-up of the microscope. Furthermore, the attached computer was of a high processing power to process the incoming signals from the SEM. The pieces were inserted into a vacuum chamber and then the central console was utilized to change the magnification and to change the orientation of the piece to the analysis face. The corresponding EDAX TEAM software was then employed to gain the composition of each test piece. Two different methodologies were performed to ensure the accuracy of the results:

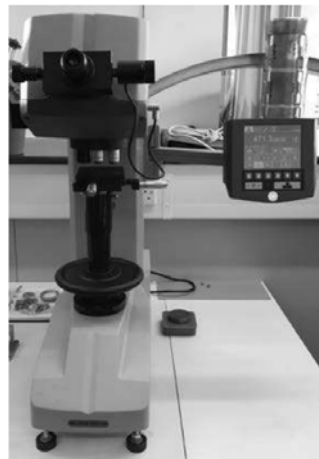
**Figure 5.** Wilson hardness testing machine utilized in the current research.

A hardness test, in addition to the material hardness assessment, is used as one of the well-known techniques for estimating the yield strength of a material without performing a tensile test (in cases where there is a shortage of material to fabricate a tensile test specimen). In most metal materials, Vickers hardness is approximately three times the yield strength in MPa [39]. Figure 5 shows the testing machine utilized to measure the hardness values at pre-determined locations. This device was calibrated before each use to ensure that the obtained values for the hardness are of a high accuracy. To this end, a diamond indenter was utilized with a load of HV10, and it was applied for a time of 10 s to create the pyramid indent, which was then scaled using the dedicated microscope to obtain a HV value for the tested location. There was a total of seven samples, and all of them were tested on two of the four faces to ensure the accuracy of the results. Moreover, 16 indents were made on each face (32 on each sample) in a straight line parallel to each other on the desired faces. Then, the mean values were used to calculate the yield strength through the above-mentioned relationship. The obtained results are also used to confirm the correlation between yield strength and hardness according to the experimental data of mechanical tests (i.e., tensile test) in future steps.

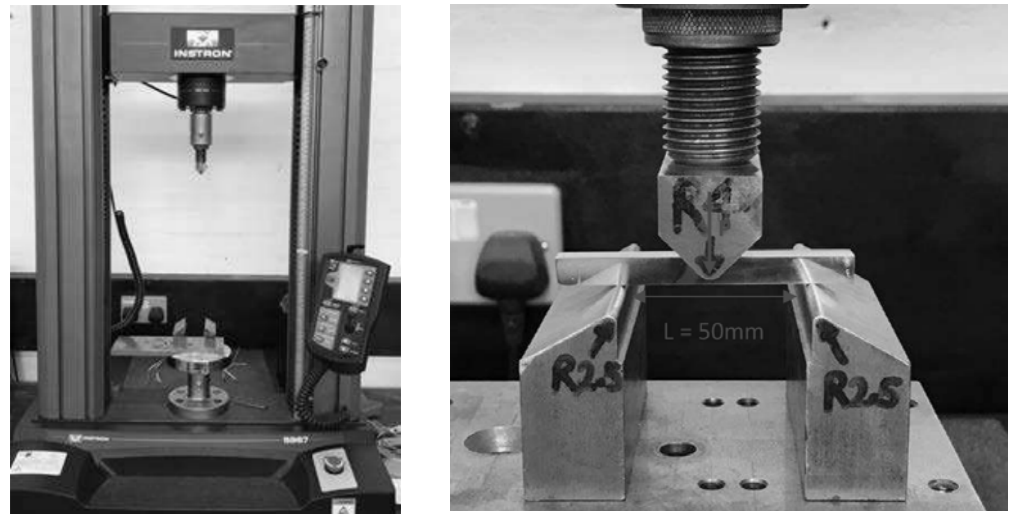
**Figure 6.** Details of the three-point flexure test performed in this research.

The fixture settings, the sample installation details, and the dimensions of the fixed and movable rollers (radius) are presented in Figure 6. In addition, the distance between the fixed rollers is equal to 50 mm and the force ( $P$ ) is applied in the middle of the sample.

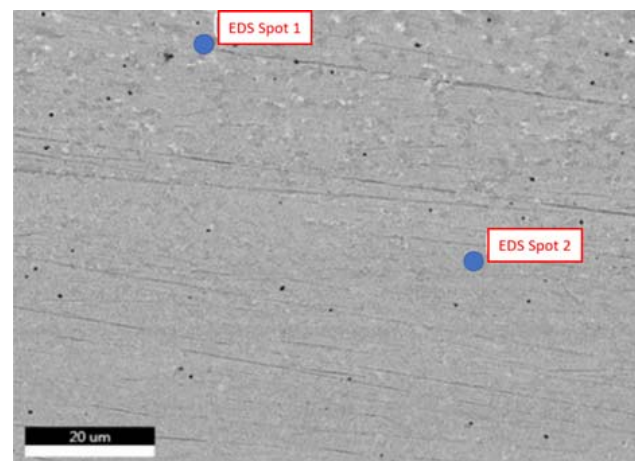
**Figure 9.** SEM image of specimen No. 1 with marked regions of compositional analysis.

After defect analysis, the samples were subjected to a SEM analysis for obtaining the composition, and to acquire high magnification images of the defects, pores, and inclusions identified in the previous step. The compositional analysis was conducted for samples No. 1 and 5, which were printed vertically and longitudinally, respectively. The analysis was conducted on different locations to ensure the results accuracy. Figure 9 shows the surface of the specimen No. 1 at the magnification of  $2938\times$ . Two points were chosen to be analyzed for the chemical composition, whereas second point was used for verification.

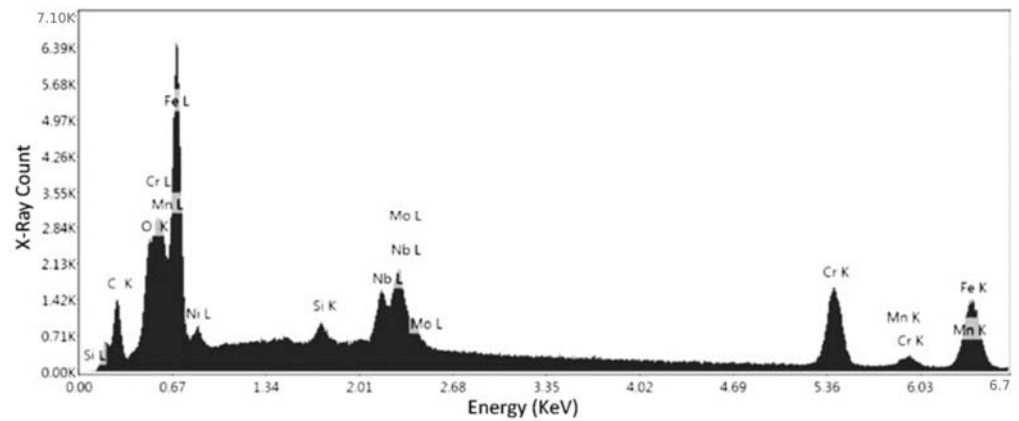
Figure 10. EDS measurement of the first point for specimen No. 1.

Figure 10 presents the elemental spectrum of first point for the specimen No. 1. Figure 10 and Table 3 present that there is a high percentage of iron (Fe: 33.48%) and chromium (Cr: 41.08%) in the specimen, along with a lower percentage of other elements, such as nickel and molybdenum. Due to the relatively high content of chromium, the alloy is most likely a stainless steel, which can be confirmed via the other chemical compositional analyses. Although Ni and Mn were shown to present in the composition, the error percentages for these elements were 81.51% and 44.38%, respectively. In detail, the elements and their isotopes, alongside the weight percentage at the specific point, their net intensities, the K-ratio (ratio of the intensity in the specimen to the standard element), and the Z

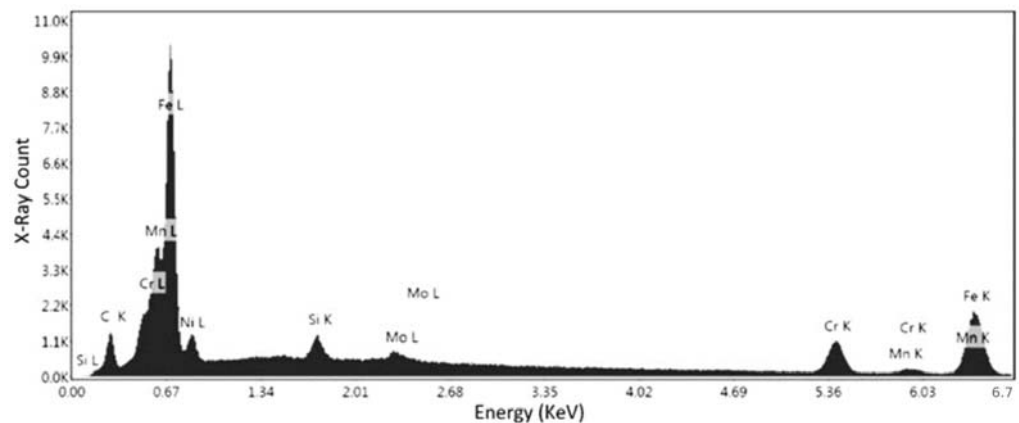
Figure 11. EDS measurement of the second point for specimen No. 1.

Figure 11 and Table 4 represent the confirmation elemental spectrum in the second point of specimen No. 1. The results compared to the first point show that there is still a sharp peak of iron, but there is a lower percentage of chromium in the composition. The error percentages for Ni and Mn were 19.84% and 9.40%, respectively. Although the nickel error rate is still high, the Mn error rate contradicts the results of the first point, so this needs to be confirmed. This confirms that the alloy is definitely ferrous in nature, and the weight of the chromium (29.82%) present leads the alloy towards being a stainless steel, as alloys with more than 10% chromium content are classified as stainless steels. This is the compositional analysis of specimen No. 1, which was printed in the horizontal orientation. Thus, a specimen from the second batch was also analyzed to check and confirm the inference of stainless steel for samples.

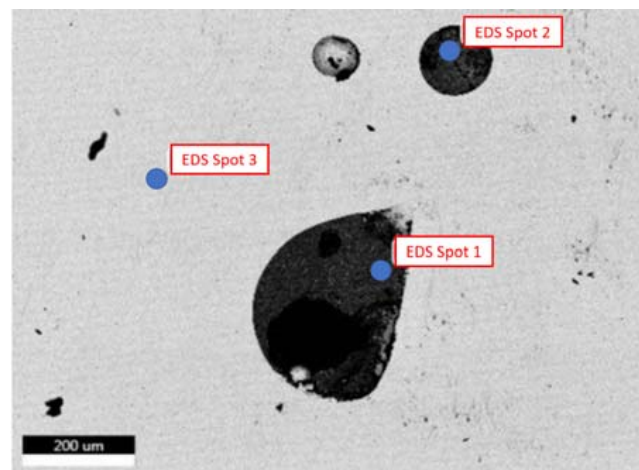
**Figure 12.** SEM image of specimen No. 5 with marked regions of compositional analysis.

Specimen No. 5 was also analyzed using the SEM. The parameters set in this case were 10 kV for the electron beam voltage, a 250× magnification, and a scan time of 96.8 s. In addition, compositional analysis was conducted via EDX spectroscopy, and the defects were also analyzed. Figure 12 depicts the certain locations where the compositional analysis was conducted. First and second point were analyzed to assess the nature of these defects and their relevant data are available in Figure 13, Table 5 and Figure 14, Table 6, respectively.

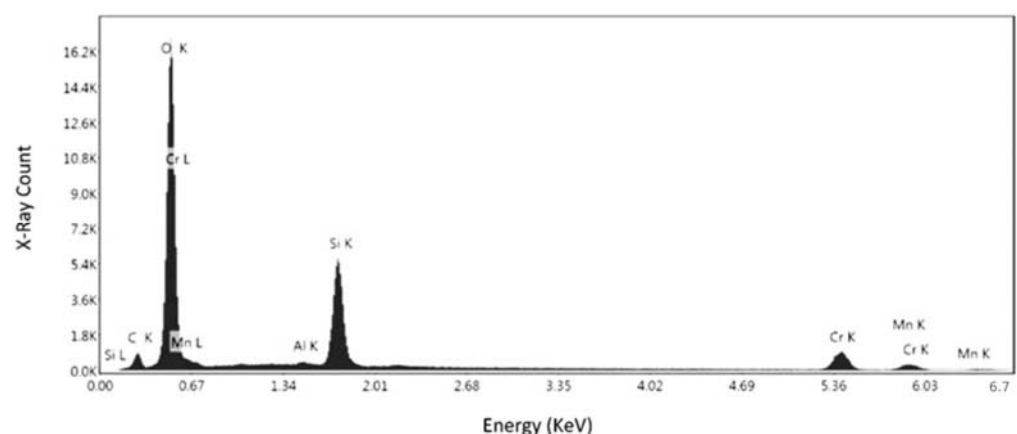
**Figure 13.** EDS measurement of the first point for specimen No. 5.

Based on the results presented in Figure 13 (observation of oxygen peak) and the relative weight of oxygen in Table 5, which proves the presence of oxide in this location, the first point indicates the oxidation defect. Moreover, the high composition of chromium peak (Figure 13) and its relative weight percentage (Table 5) indicate that these are chromium oxides.

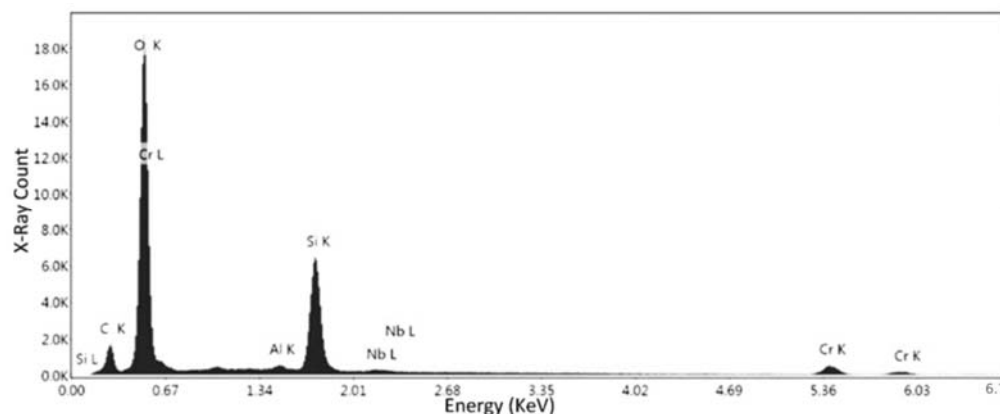
**Figure 14.** EDS measurement of the second point for specimen No. 5.**Table 6.** Chemical composition as the result of EDS analysis in specimen No. 5 (second point).

From the results presented in Figure 14 and Table 6, it is observed that the conditions of the second point are very close and similar to the conditions of the first point. However, there is a big difference in the relative weights of oxygen and chromium in the first and second points, but the spectrum is almost the same. Therefore, it turns out both are a kind of defect (chromium oxides).

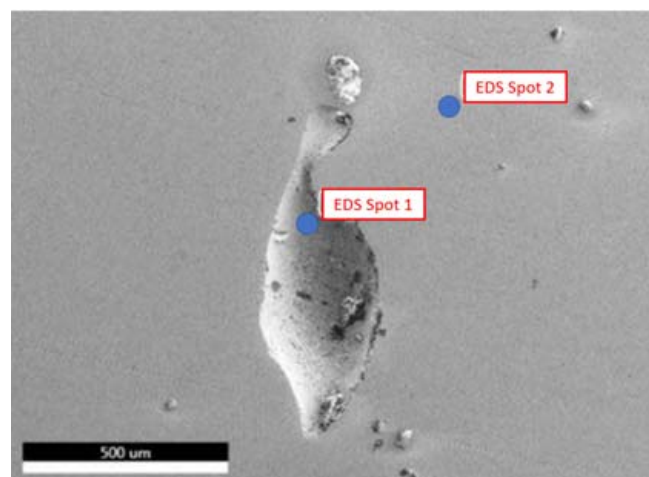
Figure 16. SEM image of specimen No. 5 with marked regions of compositional analysis to study the lack of fusion defect.

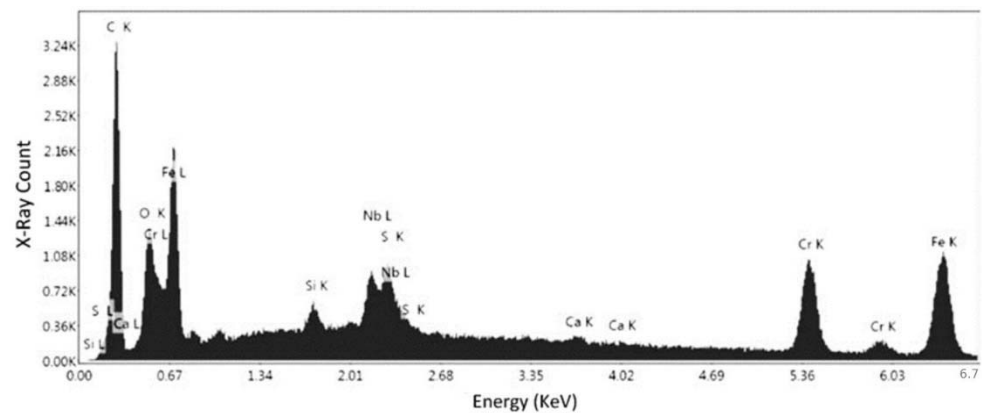
Figure 17. EDS measurement of the first point for specimen No. 5 to study the lack of fusion defect.

Figure 17 depicts the elemental spectrum of the first point, and the recorded data for these elements are given in Table 8. The results showed that the current defect is composed of Iron (16.6%), Carbon (24.38%), and Chromium (45.66%). This reveals that the present defect is lack of fusion, as the composition is relatively the same as the surface composition assessed on specimens No. 1 and 5. The presence of carbon in such a large quantity in this case can be disregarded, and is not due to the defect, as seen in previous analysis, the surface compositions also display a large quantity of Carbon.

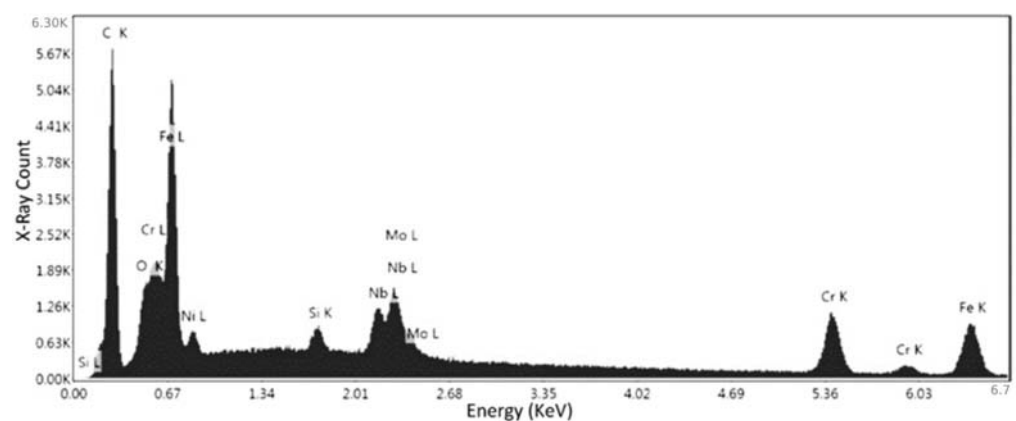
Figure 18. EDS measurement of the second point for specimen No. 5 to study the lack of fusion defect.

From Table 9, the relative weight of these elements is 27.07% and 30.77%, respectively. This further proves that the powder utilized in the formation was an Iron-Chromium alloy.

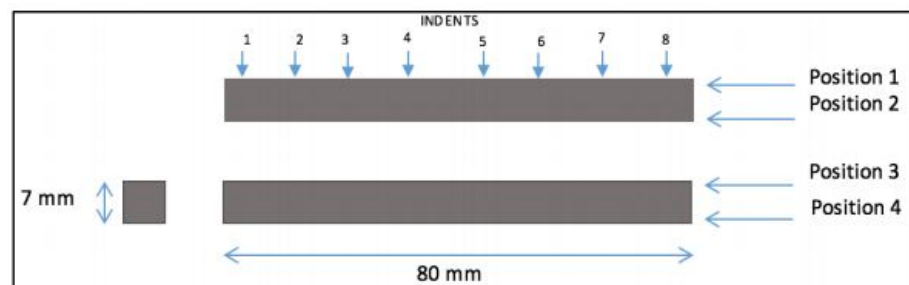
**Figure 20.** Details of different paths and the positions of indentations in the microhardness test.

The hardness testing was conducted on two faces and four linear paths as shown in Figure 20. Moreover, eight points were tested in each path and each test was repeated twice. In other words, the mean value of the two tests indicates the hardness of that point. Figure 21 presents all the results obtained from microhardness tests for different specimens. The overall average of hardness was 452.35 HV and the yield strength was calculated to be about 150.8 MPa.

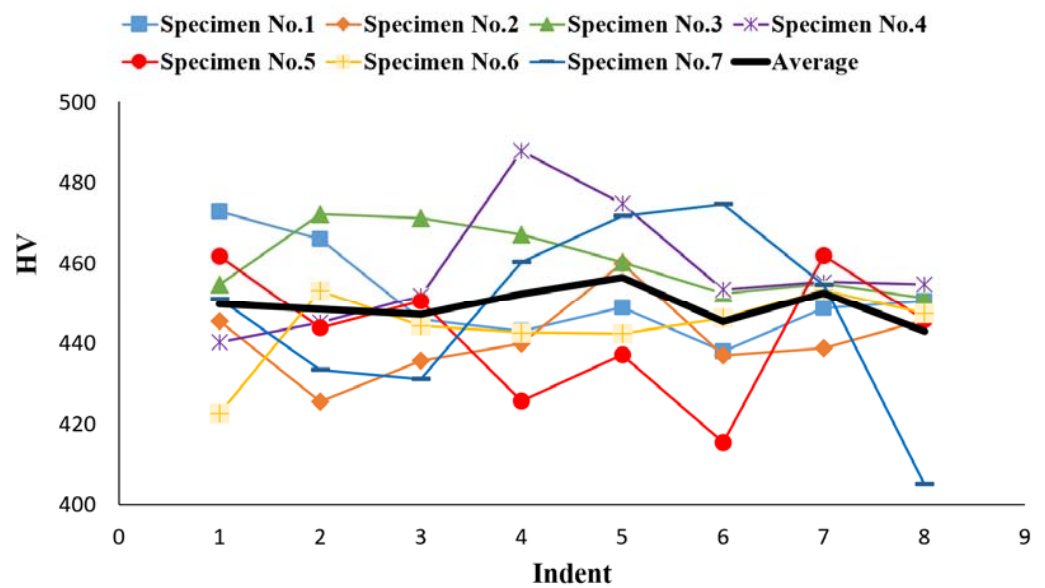
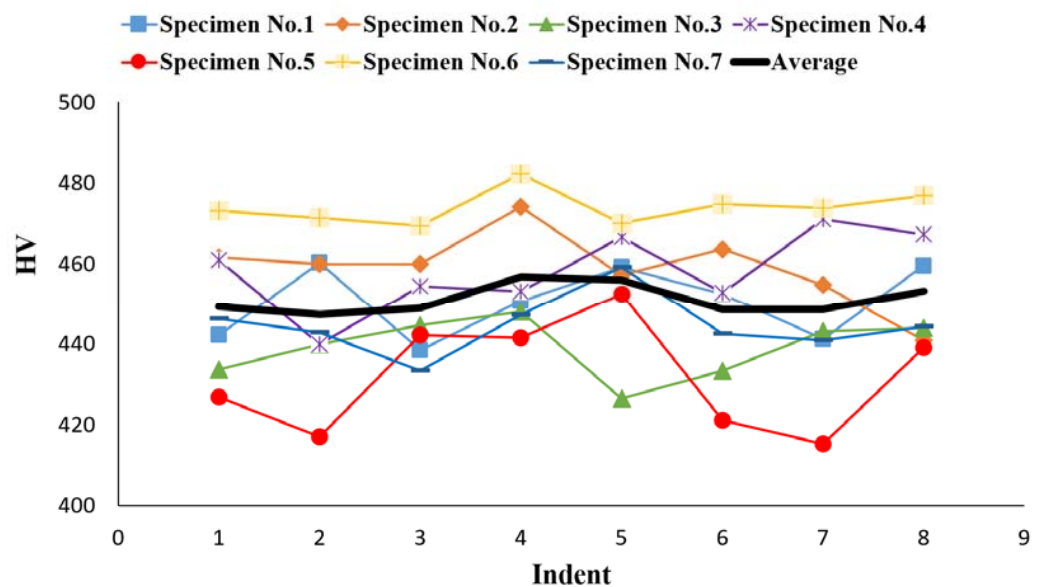
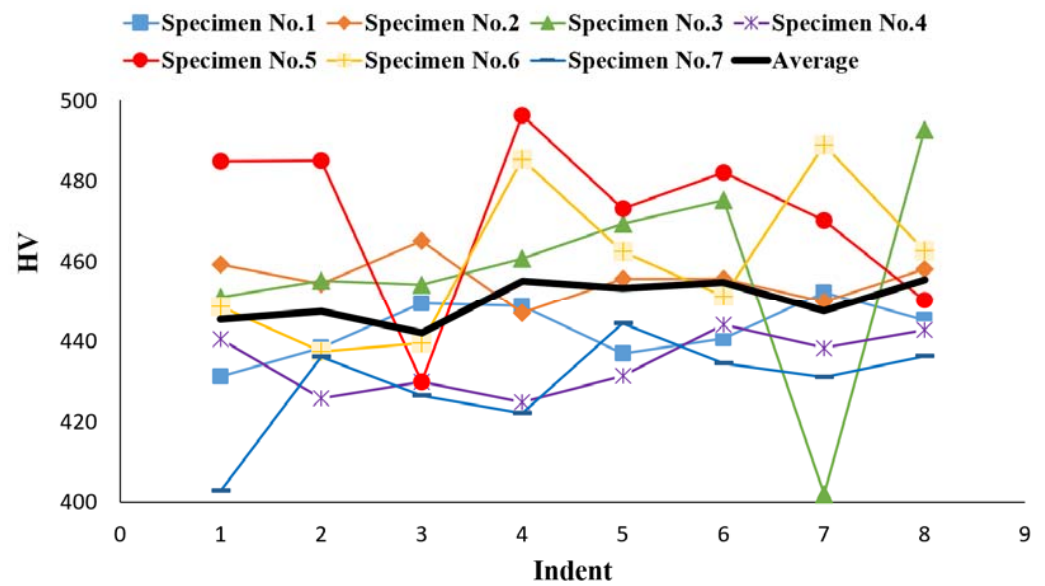
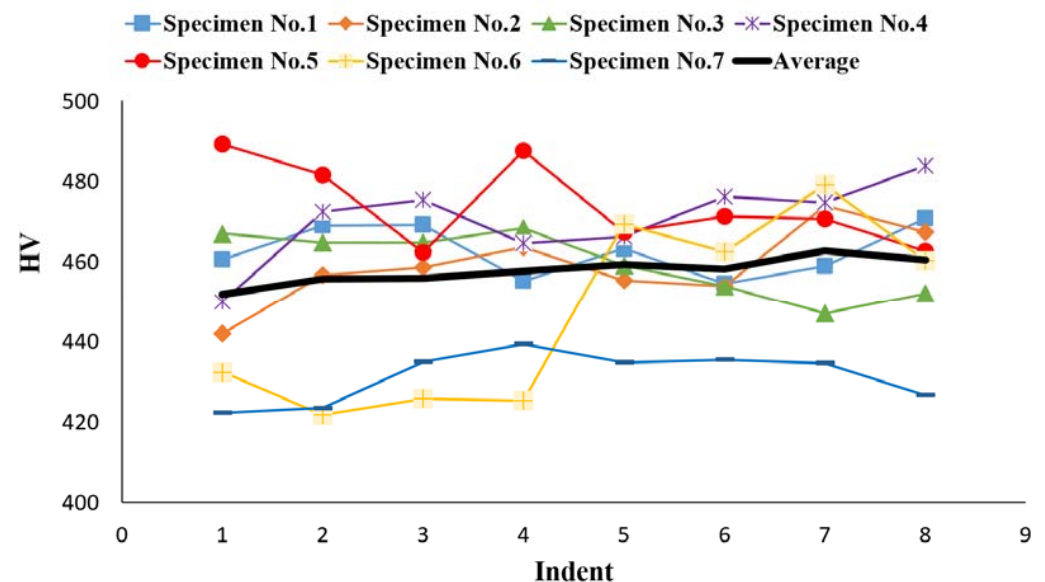
**Figure 21.** Microhardness graphs on different positions, including (a) position 1, (b) position 2, (c) position 3, and (d) position 4.

Figure 21a depicts the position values for the hardness of all specimens including both batches in position 1. Similarly, the results obtained in different positions (2, 3, and 4) are shown in Figure 21b–d, respectively. Moreover, details of the recorded values are reported in Appendix A (Tables A1 and A2). In these figures, the mean values are presented by the black line, which, in all cases, is in the value range of 450 HV. Although most of the recorded values fell within the error band, specimen No. 4 at indent 4 and specimen No. 7 at indent 8 showed a massive fluctuation compared to the other specimens. This is due to a human error in analyzing the pyramid or due to an error during test. These large variations were observed in other positions as well as in various indentation places of different specimens. Since the number of this event is small compared to the number of the performed experiments, therefore this error can be ignored.

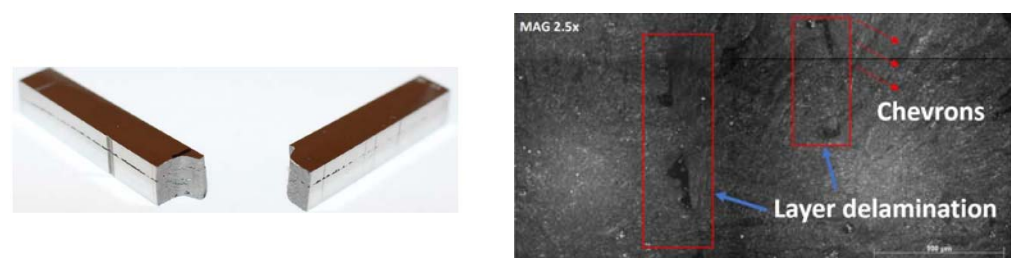
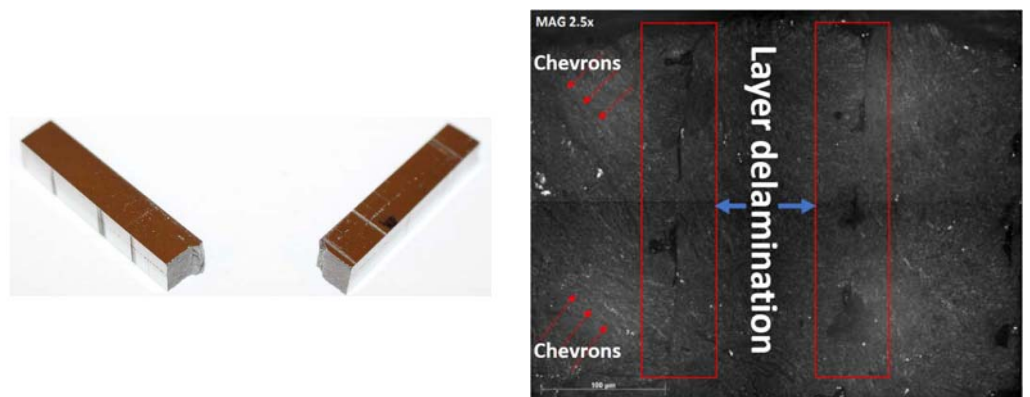
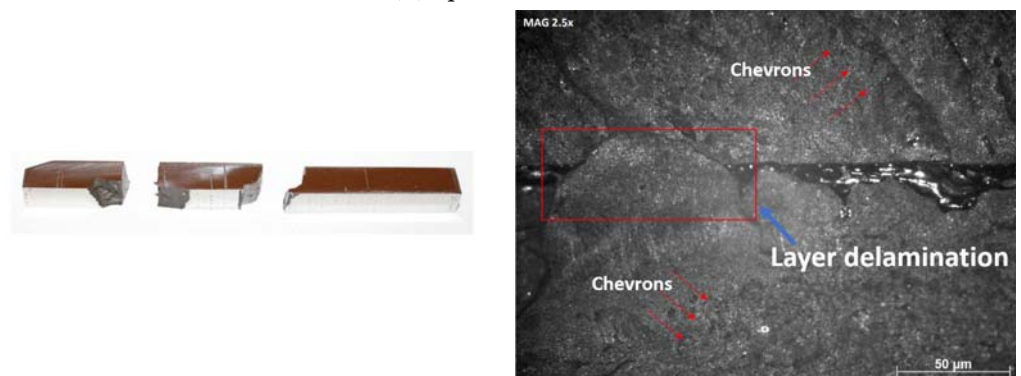
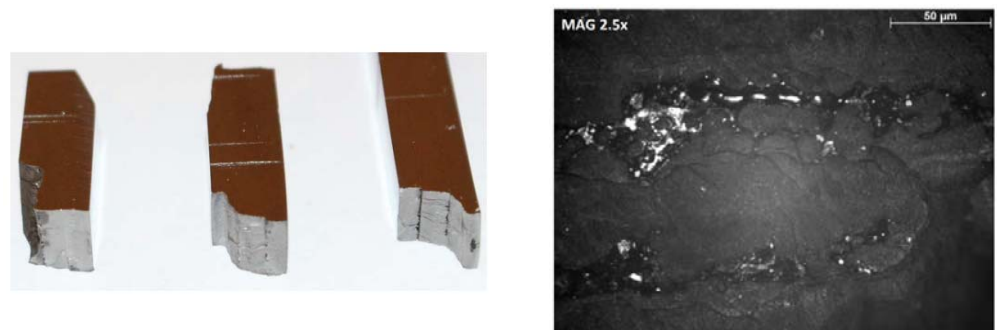
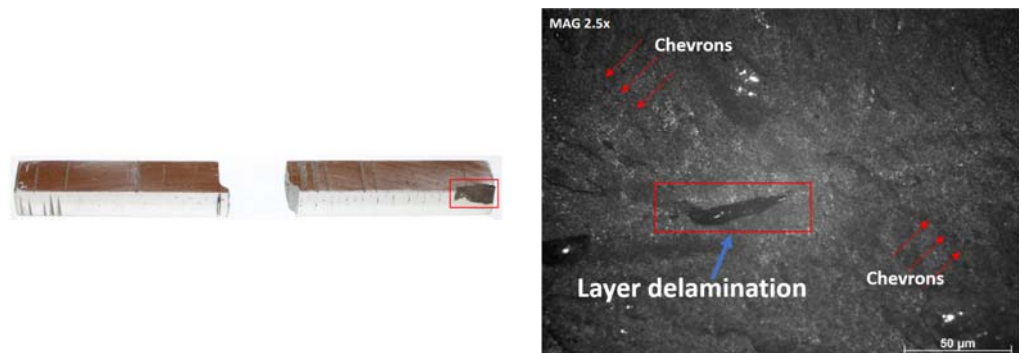
**Figure 23.** Fractured specimens and their respective surface features.

The load-extension graphs assessed prior point towards the conclusion that the specimens fractured in a brittle fashion, as there was a lack of plastic deformation. Figure 23 display the fractured specimens and their respective surface features. Figure 23a depicts the two fragmented pieces of specimen No. 2. It is clear that there is extensive layer delamination, where, visibly, there are only four layers in the specimen and the lack of fusion defects are integrated into these. The lack of fusion between the layers is the most probable cause for the layer delamination. Moreover, it is obvious that there was a clean break, with little to no plastic deformation, and visibly the surface can be seen to exhibit brittle features and is flat. In other words, all the common features in brittle fractures [42] can be seen in this specimen. To further assess the nature of the fracture and the material properties, the surface of the specimen was analyzed via SEM images. In this figure, the layer delamination can clearly be seen as marked in red boxes. The pattern on the surface, more specifically the V-shaped marks (more visible on the right side as indicated by the red arrows), are called “chevrons”. These are mainly features related to brittle fractures, thus confirming the initial assessment [42]. Figure 23b depicts the fragmented pieces of specimen No. 3. Evaluation of this sample showed the similar results to sample No. 2 (the layer delamination and the lack of fusion are interconnected). This layer delamination is most likely due to the printing method and process parameters such as high scan speeds and low laser power.

Due to the parameters for these specimens not being disclosed by the manufacturer, this is only a hypothesis. SEM image of failure surface of this specimen also exhibited similar features to specimen No. 2, where there are chevrons present (red arrows), which is a common brittle fracture pattern, and the layer delamination due to lack of fusion can also clearly be seen (red boxes). The interpretation of the images related to specimen No. 5 is demonstrated in Figure 23c. It is the most interesting fracture, as the specimen fractured at two points, rather than at the one point where the stress was concentrated during the flexure test. This could be due to human errors during the apparatus set up. During the testing phase, this specimen shot off after fracturing and the impact due to high velocity could be the causality leading to the secondary fracture. The primary fracture displayed the features indicating a brittle fracture, like the previous specimen. Although an interesting observation is that the surface is not entirely flat, this points towards an intergranular brittle fracture. An intergranular fracture is when the crack propagates along the grain boundaries and continues until the fracture is complete [42]. Figure 23d depicts the surface of the primary fracture for specimen No. 5. The features exhibited here such as the chevrons patterns depicted by the red arrows, are an indicator for a brittle fracture. In addition to these issues, the surface analysis showed similarities to the previous specimens, except some interesting observations. The layer delamination wasn't complete, as depicted by the red box in this figure; the powder seems to have melted and completed the connection of the two layers and is most likely a printing error. Figure 23e illustrates the fragmented pieces of specimen No. 6. The fracture was very similar to specimen No. 3, and it exhibited the same brittle fracture properties. An interesting feature of this specimen is the damage at the edge. This is due to the specimen shooting off from the apparatus at a high velocity after the fracture. The layer delamination was not as significant in this specimen, and also it is hard to distinguish between the layers, which was much easier in the previous specimens. This makes this specimen structurally better than the other specimens, as the lack of fusion is less and the defects surrounding these are not as significant, thus not compromising the structural integrity as much. Moreover, the fracture surface exhibited clear chevron patterns as represented by the arrows on the image.

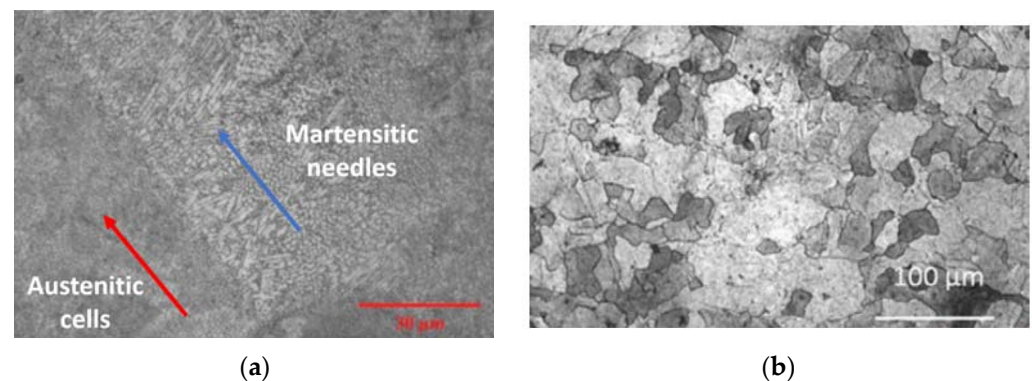
**Figure 24.** (a) Surface microstructure of SLM printed stainless steel directly from the substrate [43] and (b) SLM printed stainless steel microstructure following 1100 °C heat treatment [43].

due to the finer grain structure obtained from the AM techniques due to the solidification speed [45]. Moreover, the properties reported for the traditionally formed stainless steels were calculated and obtained in accordance with ISO and ASTM standards. Since the specimens were directly taken from the substrate without any post-processing treatments, this may have adversely affected the mechanical properties and explaining the difference in the above-comparison [46]. To achieve a certain mechanical property, most SLM parts undergo heat treatments to alter the microstructure, change the grain size and orientation to better suit the needs of the application [47,48]. As seen in Figure 24a, the microstructure and grain size evaluated in the previous section are similar to the results obtained for stainless steel in other studies. The visible difference being the orientations, as there are two distinct regions, marked by the red and blue arrows. This is due to the island scan strategy being applied, which melts the powders in alternative directions following each layer. In this research, the brittle nature of the metals was altered via heat treatments by increasing the grain sizes. In this regard, Figure 24b depicts the microstructure of the metal following a heat treatment at 1100 °C. It is clear that the grain size and structure have changed and are visibly much bigger in comparison. This made the structural integrity more ductile, allowing it for usage in such applications where ductility is required. The mechanical properties were also enhanced alongside the grain alteration, as they are directly related. This issue proves that the mechanical properties are highly dependent on the temperature and the final obtained microstructure. Therefore, heat treatments can be used to change the microstructure and thus significantly improve the mechanical properties [43].
