Al-Tabbaa, A., Litina, C., Giannaros, P., Kanellopoulos, A., & Souza, L. (2019). First UK field application and performance of microcapsule-based self-healing concrete. *Construction and Building Materials*, 208, 669-685. DOI: 10.1016/j.conbuildmat.2019.02.178

5 First UK field application and performance of 6 microcapsule-based self-healing concrete 7

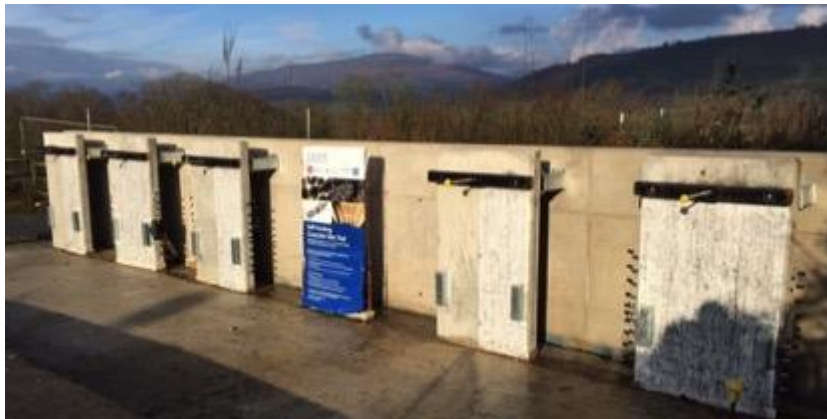
216
217 **Figure 3 Self-healing concrete wall panels constructed within the EPSRC and industry funded**
218 **Materials for Life (M4L) project [35].**

211 concrete panels were cast- each being 1.8m tall, 1m wide and 150mm thick (shown in Fig. 3). Details
212 of the design and execution of the field trials were presented elsewhere [34,35]. One of the panels
213 contained the developed microcapsules and there was a control panel without any microcapsules with
214 which a comparison was made. This paper focuses on the former. It presents details of the scaling up of
215 the microcapsules and their use in the field trials and subsequent performance and monitoring.

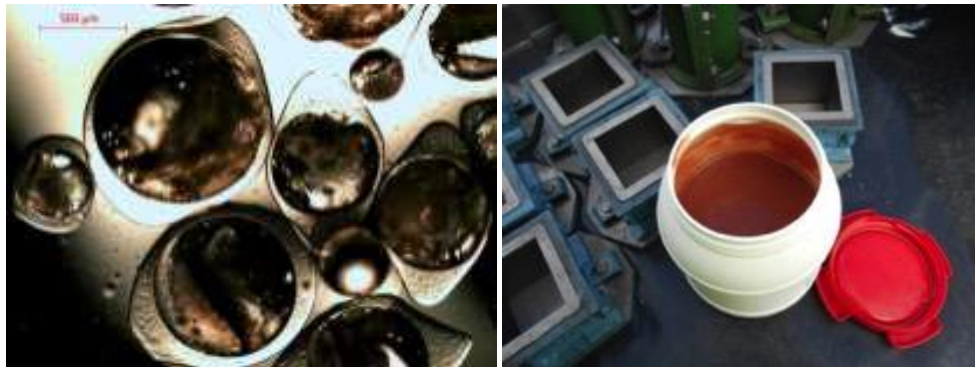
234 The concrete mix composition is detailed in Table 1. The microcapsules were first washed with water
 235 and filtered from their preserving solution before being added, in their slurry form, directly into the
 236 ready-mix C40/50 concrete using a portable 120L Belle concrete mixer. The microcapsules were added
 237 at 8% by volume of the cement, corresponding to $\sim 2.67\%$ by weight of the cement and $\sim 0.47\%$ of the
 238 total concrete mix. A small quantity of water was used to wash out the microcapsules from the
 239 container and as a result the effective water-to-cement (w/c) ratio of the concrete mix increased from
 240 ~ 0.43 to ~ 0.45 . A control panel was also cast without any microcapsules.

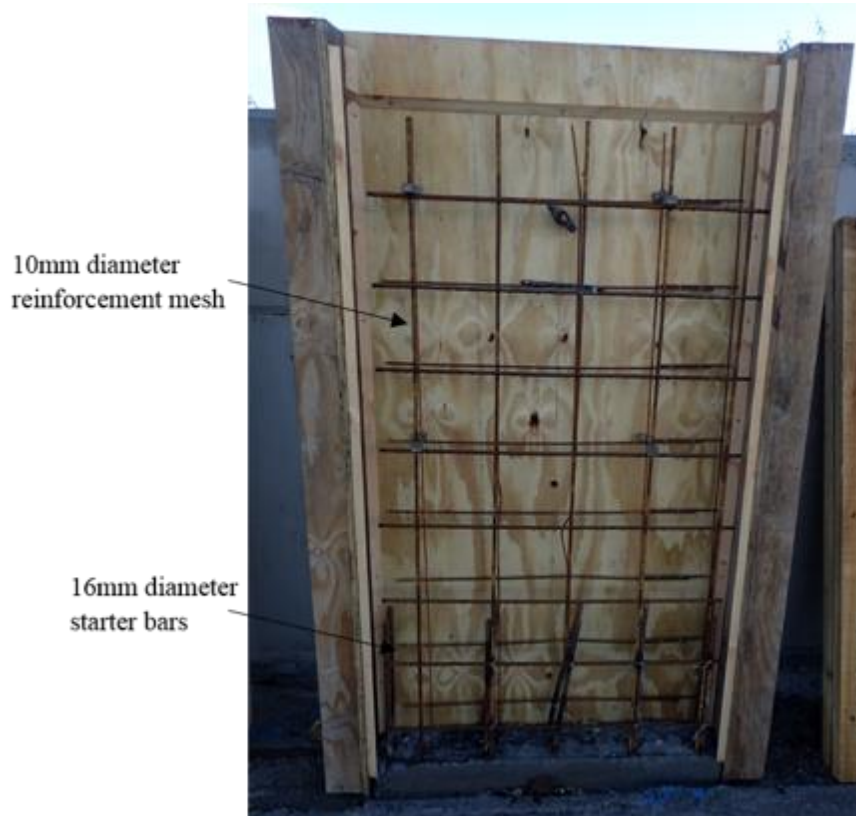
272
273 **Figure 5 Wall panel reinforcement design to ensure cracking at ~500mm from the base of the wall**
274 **panel.**

251 The wall panels were designed to crack 500mm from the base upon loading, which was facilitated by
 252 using 16mm diameter starter bars on the front face up to the designed crack location, before changing
 253 to the 10mm diameter mesh to create a weak section in the panel as seen in Fig. 5. Loading was
 254 applied using a hydraulic jack positioned 1.5m above the base of the panels, i.e. near the top of the
 255 wall, that was used to pull a threaded bar; thereby inducing a cantilever load. A wailing beam attached
 256 to the front of the panel allowed a distribution of load across the width of the wall. Full details of the
 257 design and construction of the walls is given elsewhere [35]. Panels were painted with a black-and-
 258 white speckle pattern for digital image correlation (DIC) analysis to monitor wall displacements and
 259 associated strains that arise during loading and unloading (Fig. 6).

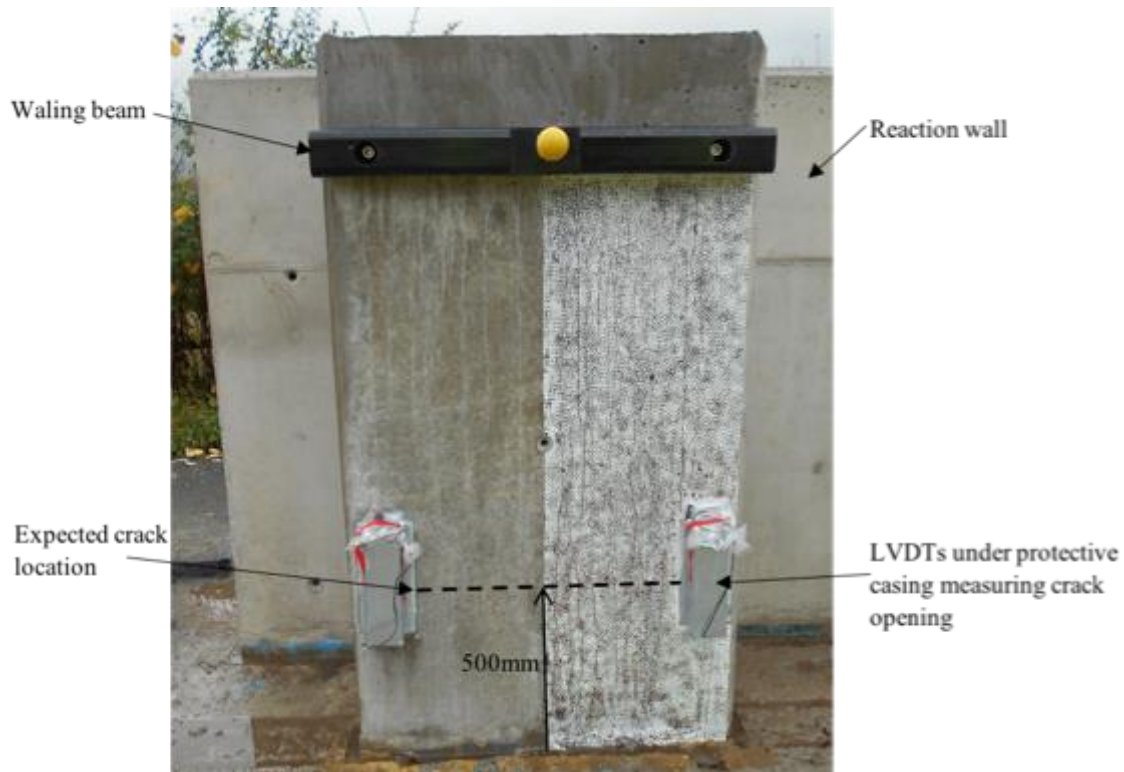
275
 276 **Figure 6 The microcapsule wall panel half painted with a black-and-white speckle pattern for DIC**
 277 **analysis**

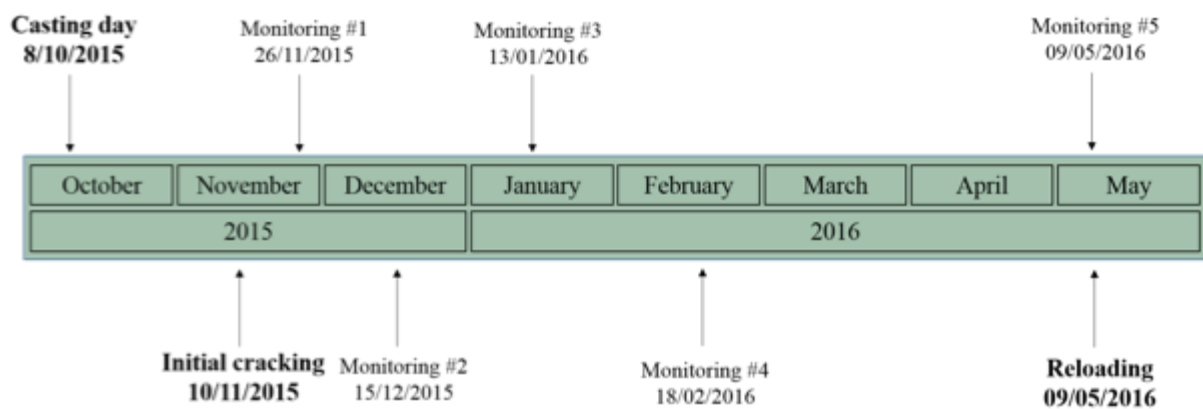
299 **Figure 8 Timeline of wall panels testing and measurement collection dates**
 300

282 A timeline of the field trials experimental programme is given in Fig. 8. The wall panels were initially
 283 loaded 5 weeks after their casting day and then reloaded after a 26-week healing period. Loading was
 284 applied until a noticeable crack appeared at the designed height and a large drop-off in load was

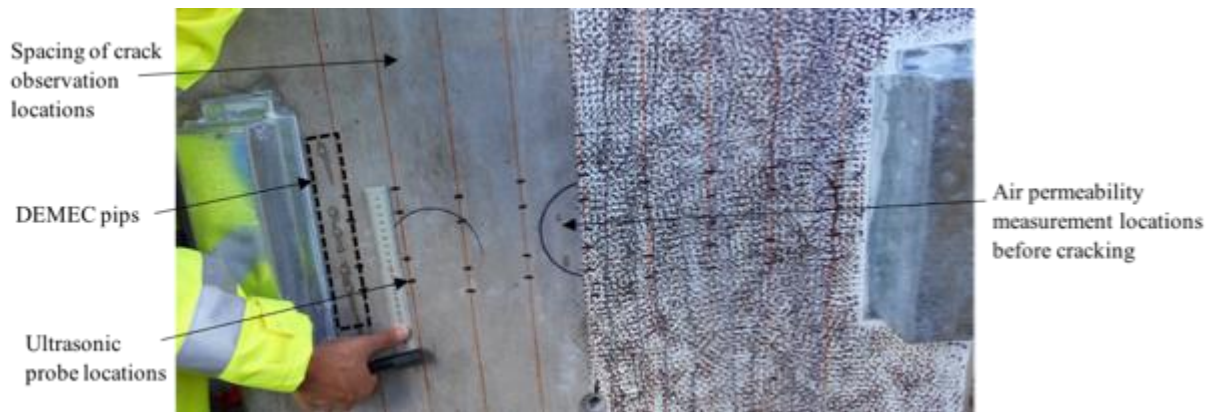
301 **Figure 9 Location of DEMEC pips, ultrasonic probe measurement locations and air permeability**
 302 **measurement locations.**
 303

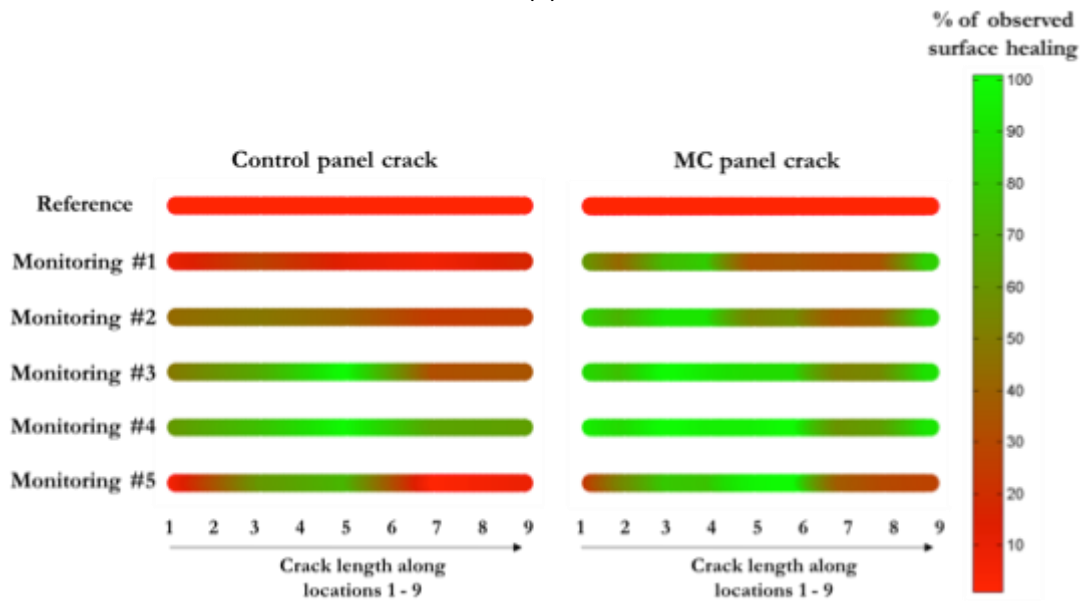
Figure 14 Monitoring crack width healing in panels: (a) microcapsules wall panel showing the locations (numbered 1-9) at which discrete crack width measurements were taken and (b) continuous crack width healing percentage plots for both panels.

415 Interpolation of crack width measurements on different locations along the crack length (shown in
416 Fig. 14a) can be seen in Fig. 14b in which the colour-bar indicates the level of crack closure achieved.
417 Similar crack width healing characteristics are seen in both panels with less healing observed on the
418 right-hand side of wall panel due to the paint required for the DIC speckle pattern. The paint has a
419 waterproof characteristic and therefore water runs off the surface rather than permeating into the
420 crack and contributing to clogging of the crack mouth. Accelerated average crack healing along the
421 main crack location, of 49% and 63% was evident as early as monitoring events #1 (14 days) and #2
422 (28 days) for the MC panel compared to 14% and 36% respectively, observed in the Control panel.
423 These results not only confirmed preliminary investigation for mortars specimen [21] but also were in

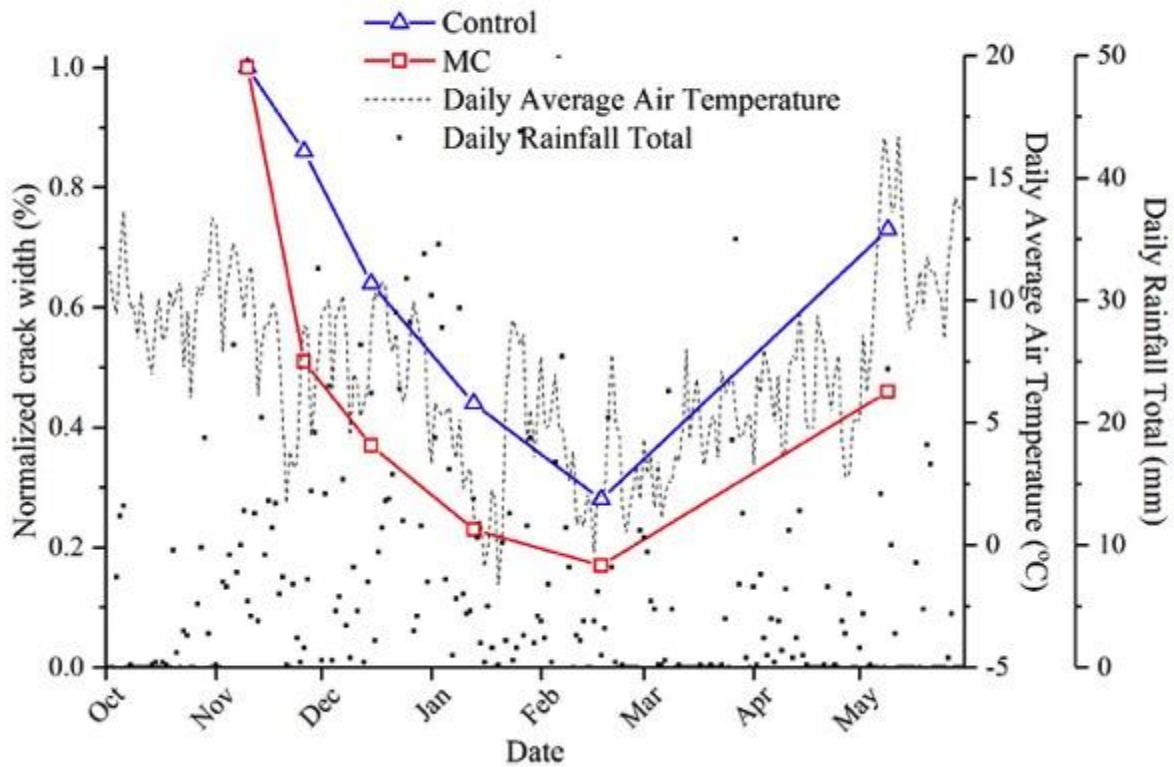
479 **Figure 15 Monitoring crack width healing in panels: (a) microcapsules wall panel showing the**
 480 **locations (numbered 1-9) at which discrete crack width measurements were taken and (b)**
 481 **continuous crack width healing percentage plots for both panels.**

444 contributed to the change in crack width measurements. The mean crack width obtained over the
445 monitoring period can be seen in Fig. 15a along with the daily average air temperature obtained from
446 local weather stations. Crack width measurements are normalised with respect to the width obtained
447 following load removal (i.e. residual crack widths). A trend is clearly observed between the daily
448 average air temperature and the normalised crack width in both the microcapsule and control panels.
449 Crack width measurements constantly reduced during the first four monitoring events (between
450 November 2015 and February 2016). However, the normalised crack width increased for the final
451 monitoring event before reloading of the panels in May 2016 although the measured width is still less
452 than the residual crack width measured upon initial loading of both panels. This indicates that

467 Observations of daily rainfall totals also suggest the contribution of rainwater to the healing process.
468 Fig 15b shows the average normalised crack width along with daily rainfall totals. The greatest amount
469 of rainfall is observed during the first three months after initial cracking; namely in December, January
470 and February. Water is necessary for the reaction of the released sodium silicate with the hardened
471 cement matrix. Furthermore, the presence of water is one of the most important criteria for successful
472 autogenic self-healing [40,41]. The temporary addition of insulation to the microcapsule panel in the
473 first two weeks of monitoring did not appear to have affected the obtained results. Theoretically, less
474 self-healing is expected in the locations that were covered due to water deprivation in the cracks
475 limiting both autogenic and autonomic self-healing processes. However, in this wet environment, the

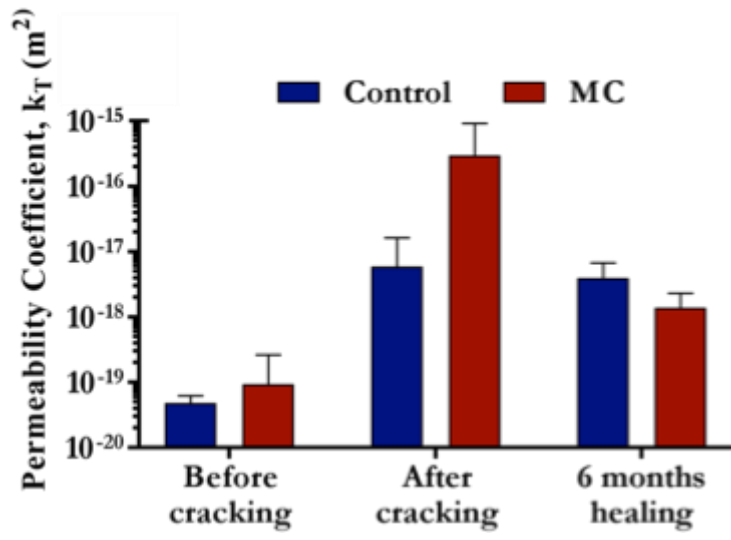
Figure 17 (a) Permeability of wall panels before cracking, after cracking and after a 6-month healing period and (b) Air permeability measurement locations after loading and subsequent cracking of concrete wall panel.

496 The coefficient of air permeability values measured at three periods are shown in Fig. 17a, showing
 497 very similar values of $\sim 10^{-19}$ kT for both walls before cracking suggesting that the microcapsules did not
 498 significantly alter the initial porosity of the concrete. This value is typical for concrete of very low
 499 permeability [42]. After cracking, the air permeability of the microcapsule wall was noticeably greater
 500 than the control wall by ~ 2 orders of magnitude. Since the microcapsule wall failed at $\sim 8\%$ lower load
 501 than the control panel and hence slightly weaker, it is possible that this had induced a greater content
 502 of internal microscale damage and cracking. It should be noted here, that it was not possible to obtain
 503 air permeability measurements after cracking from all of the same locations prior to cracking. When
 504 placing the device in locations directly over the induced crack, the device was unable to create a

624 The significant reduction in crack depth in the microcapsule wall hence cannot be due to the
625 deposition of calcite alone. As well as the contribution from autogenic healing, autogenic healing due
626 to the release of microencapsulated sodium silicate occurred. Microcapsules on the crack surface that
627 were embedded within the cementitious matrix showed rupture and formed dense hydration
628 products at the outlet. TGA results also showed a greater degree of hydration for the microcapsule
629 wall; suggesting more hydration processes had occurred in comparison with the Control panel. Finally,
630 air permeability measurements taken around the crack location also showed significant healing for
631 the microcapsule wall in comparison to almost no healing in the Control wall (Fig. 17). These results
