MECHANICAL BEHAVIOUR OF SELF-PIERCING RIVETED ALUMINIUM JOINTS

**A thesis in partial fulfillment of the requirements of
the University of Hertfordshire for the degree of Doctor of Philosophy**

**The programme of research was carried out in the department of Aerospace,
Automotive and Design Engineering, University of Hertfordshire
in collaboration with
Alcan International Limited and Textron Fastening Systems**

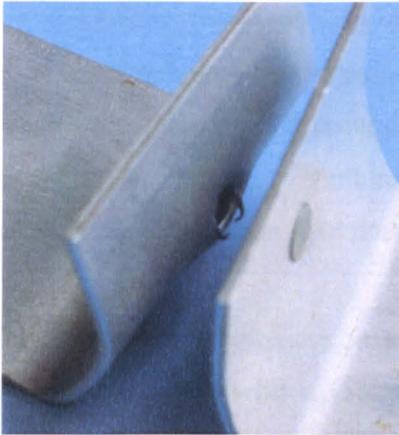
During peel testing, failure occurred by either *rivet pull-out* or *sheet material failure*. All the joints with a (2mm+2mm) thickness combination failed by the rivet being pulled out, whilst fracture of the thinner sheet occurred for all the joints with a (1mm+2mm) thickness combination. Fig.3.9 shows these two different failure modes.

**Figure 3.9 Failure modes for the peel test,
(a) Rivet pull-out failure in (2mm+2mm) joint,
(b) Sheet material failure in (1mm+2mm) joint**

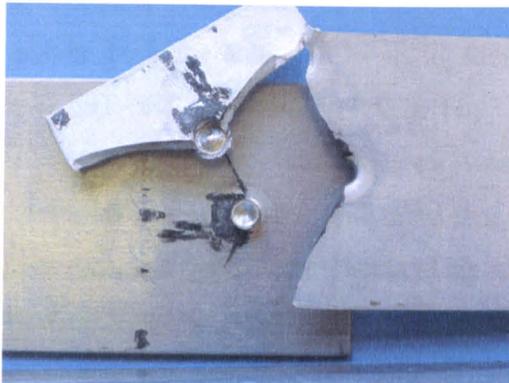
Fig.3.28 shows the failure modes that occurred during fatigue testing. Similar to the FSN5 series of fastenings with a (1mm+2mm) combination, the FSA6 series of fastenings with a (0.9mm+2mm) combination failed by *sheet material failure*, as shown in Fig.3.28 (a). The 0.9mm AA6111 pierced sheet fractured, while the rivet still connected the two sheets. At applied loads at and above 3.6kN, the FSA6 series of fastenings with a (2mm+2mm) combination failed by *rivet fracture*. At applied loads at and lower than 3.0kN, *sheet material failure* dominated the failure mode, as shown in Figs.3.28 (b) and (c). At all load levels, sheet material fracture was suffered only by the locked sheet, whilst the AA6111 pierced sheet underwent very little deformation. This was different from the observations of the failure mode for the FSN5 series of fastenings with a (2mm+2mm) combination. This indicated that the sheet material properties might affect the failure mode. Black-coloured fretting scars also formed at the interface between the two riveted sheets indicating that fretting had taken place.

Figure 3.28 Failure modes in fatigue testing, (a) sheet material failure in a FSA64* fastening that failed at a maximum load of 2.0kN after 959,680 cycles, (b) rivet fracture in a FSA62* fastening that failed at a maximum load of 4.5kN after 230,570 cycles, (c) sheet material failure in a FSA61* fastening that failed at a maximum load of 3.2kN after 3,151,960 cycles
