The effect of different metallic counterface materials and different surface treatments on the wear and friction of polyamide 66 and its composite in rolling-sliding contact

Y K Chen*, O P Modi⁽¹⁾, A S Mhay, A Chrysanthou and J M O'Sullivan

University of Hertfordshire, Faculty of Engineering and Information Sciences, Hatfield, Herts. AL10 9AB, UK.

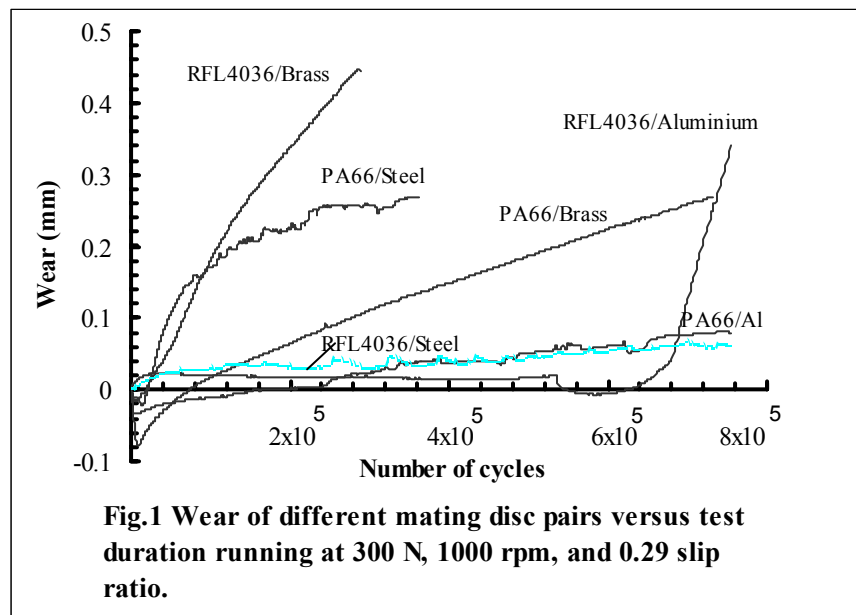
Fig.1 presents the amount of wear of the different mating disc pairs as a function of contact cycles. It is evident that the amount of wear increases with the number of contact cycles. A typical wear versus number of cycles plot may consist of up to three stages. The first stage shows an apparent negative wear right at the beginning of each test as a result of thermal expansion of the specimens. During the second stage some discs ran smoothly against each other undergoing very little if any wear. In some cases a third stage was observed where catastrophic wear took place. However, some samples suffered catastrophic wear, without going through the intermediate smooth stage. The results of these observations are summarised in Table 2.

The PA66/brass pair suffered a fast wear rate without showing an intermediate smooth stage. The wear rate remained almost constant for the whole of the test cycle. The wear rate for the PA66/steel sample was even higher initially, but it declined significantly with time as a result of the gradual formation of a visible PA66 layer on the steel surface. The PA66/2011 combination suffered the lowest wear for all the samples involving unreinforced PA66. Wear protection was provided by the formation of visible PA66 transfer film on the surface of the aluminium alloy. The RFL4036/brass pair underwent catastrophic failure right from the start of the test. In contrast the RFL4036/aluminium sample experienced a long intermediate stage of low wear followed by catastrophic wear after 6.5×10^5 cycles. The lowest wear for the composite material took place when running against EN24 steel.

The composite RFL4036 exhibited lower wear than the unreinforced PA66 when the tests were run against the EN24 steel counterface discs. The highest wear for RFL4036 was observed when brass was the counterface material. The RFL4036/2011 combination suffered the lowest wear for about 6.5×10^5 cycles, whereupon it suddenly started to wear catastrophically. It was observed during the test that the catastrophic wear was associated with the break-up of the transfer film which had been formed on the contact surface of 2011 during the period of the first 6.5×10^5 cycles. It was also noted that the wear of PA66 was the highest when it was tested against steel, while when tested against 2011 it was the lowest.

The physical observations during the tests suggest that the low wear rates when RFL4036 runs against both steel and aluminium shown in Fig.3 are correlated with dark brown coloured and more polished material on the RFL4036 contact surface. This surface feature was related to a layer of thin film on the contact surfaces as observed by surface characterisation with SEM, as shown Figs.5-6. By contrast, the phenomenon of the brown and polished surface of RFL4036 during tests does not occur when RFL4036 runs against brass. It appeared that a high value for the wear rate was due to the absence of the film on the RFL4036 surface, as shown in Fig.5c), and that the low wear rates of RFL4036 running against both steel and aluminium shown in Fig.3 corresponded to the appearance of the thin film, as shown in Figs.8a)-b). The common function of the thin film on the RFL4036 worn surfaces running against steel and aluminium appeared to keep the wear rate low. It was noted that little wear debris was found for the RFL4036/steel and aluminium combinations. Before disruption of the transfer film on the aluminium surface, the film maintained a low and constant value of the friction coefficient between two discs, as shown in Fig.2. It was observed that the disruption of the transfer film corresponded to a steep increase of wear as shown in Fig.1.

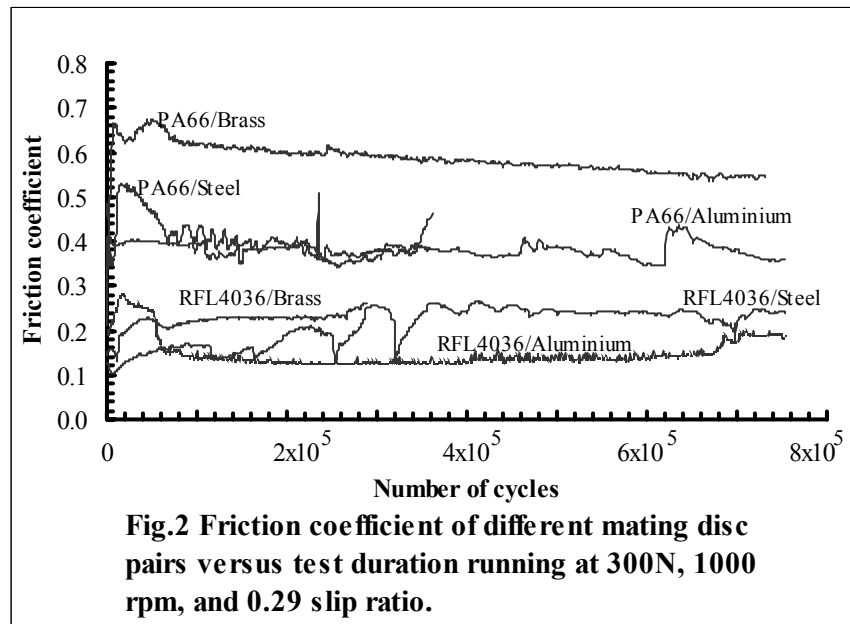
The friction coefficient of different mating disc pairs against the number of test cycles is shown in Fig.2. The friction coefficient was observed to increase rapidly at the beginning of each test, followed by practically no variation for samples where the transfer film remained intact. RFL4036 composite experienced a lower friction coefficient than the unreinforced PA66 irrespective of the metallic counterface materials used as shown in Fig.2. The reason for this is probably due to the presence in the polymer of about 15wt% PTFE that has a low friction coefficient. The value of the coefficient of friction for both PA66 and RFL4036 was observed to be at its highest when running against brass and at its lowest with 2011, while with EN24 steel an intermediate rise in friction coefficient was observed.

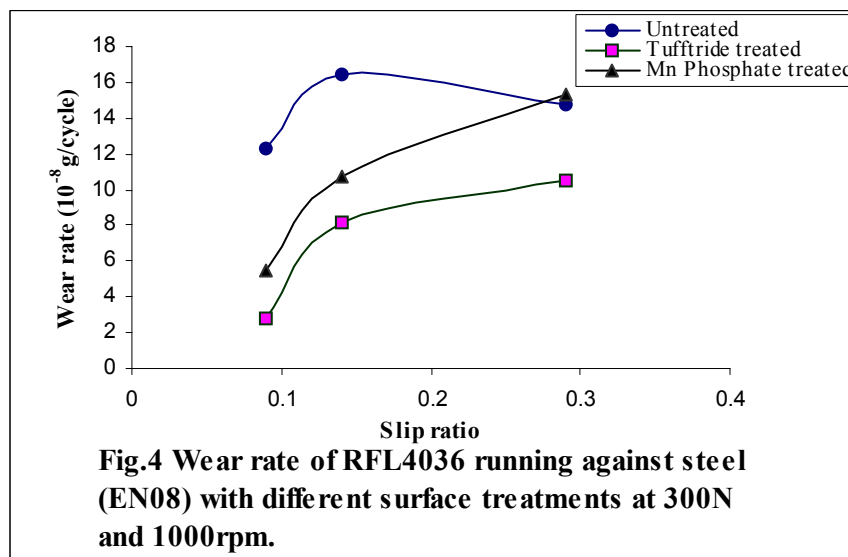
Figs.3-4 show the wear rates of RFL4036 running against different grades of untreated steel, EN24 and EN08. The wear rate of RFL4036 was 5.7×10^{-8} g/cycle when running against EN24 steel and was 14.8×10^{-8} g/cycle when running with EN08 steel. The difference between them is about 3 fold.

The effect of both the surface treatments of the mating steel (EN08) and the slip ratio on the wear rate of RFL4036 are presented in Fig.4. The wear rate of RFL4036 running against Tufftride coated steel takes lowest value of all three different surface treatments, Tufftride coated, manganese phosphate coated and untreated steel. The wear rate increases sharply from a slip ratio of 0.07 to 0.14. Then it only increases

marginally with further increase of the slip ratio. The wear rate of RFL4036 running against manganese phosphate coated steel shows a similar trend to that of running against the Tufftride coated steel. However, the wear rate of RFL4036 running against untreated steel differs from the other two combinations by taking its highest value at a slip ratio of 0.14 rather than 0.29. This combination also has lower values of the wear rate at the other slip ratios. At a slip ratio of 0.29, the wear rates of RFL4036 running against manganese phosphate coated steel and untreated steel are very close, but they are much higher than that of RFL4036 running against the Tufftride coated steel.

The difference in the wear behaviour of the RFL4036 when running against the two different steels, EN24 and EN08, is attributed to the ability to form a transfer film on their contact surfaces. It was observed that the friction coefficient for the RFL4036/EN08 pair was around 0.32 and that for the RFL4036/EN24 combination fluctuated between 0.14 and 0.26. It appears that the lower friction coefficient for the RFL4036/EN24 pair is due to efficient lubricant function of the thin film on the EN24 surface. In other words, it is easier for the transfer film to form on the EN24 surface than on the EN08 surface, consequently, the wear rate of RFL4036 when running against EN24 steel is much lower than that running against EN08.

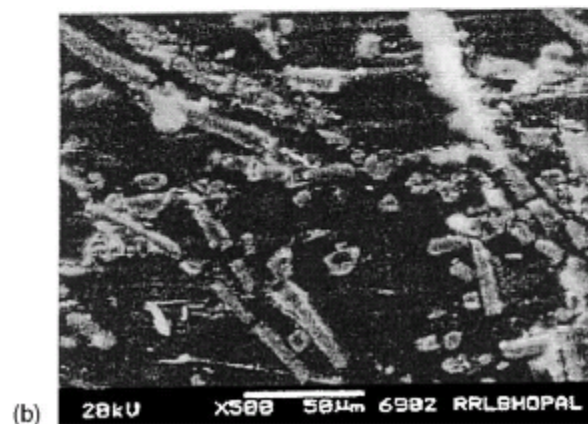
Fig.5 shows the worn surfaces of RFL4036 when it was tested against three different mating materials. Figs.5a)-5b) show that the RFL4036 worn surfaces against both steel and aluminium become very smooth and that a thin layer of film appears on both of the worn surfaces. It can be seen that the film on the RFL4036 surface running against steel has been disrupted locally and part of film has been ploughed away from the surface. The RFL4036 worn surface running against aluminium shows the film maintaining its integrity. By contrast, Fig.5c) shows a completely different worn surface feature of RFL4036 against brass. A large amount of debris still remains on the worn surface, as shown in Fig.5c), even although a high amount of debris was expelled from the contact surface of the discs during the test. The brass debris was visibly recognisable compared with RFL4036 debris.

Fig.5 Typical worn surfaces of RFL4036 running against different counterface materials at 300N, 1000rpm, and 0.29 slip ratio; direction of friction from right to left. (a) RFL4036 against steel, (b) RFL4036 against aluminium, (c) RFL4036 against brass.

On the other hand, more damage on the surface in terms of large size pits/craters were noted when RFL4036 was slid against brass. Fig.5c) shows a high amount of debris still on the worn surface during the test. Observation by SEM suggests that there were many broken fibres on the contact surface of the RFL4036. Those broken fibres were not covered with the transfer film so they caused effective abrasive wear on the brass contact surface. In fact, the brass experienced a slightly higher wear rate than the RFL4036 when they were tested as a mating pair and more brass debris than RFL4036 debris was observed. As can be seen in Fig.5c), a large amount of debris remained on the RFL4036 contact surface acting as abrasive particles during wear process. The brass particles, in return, resulted in severe wear on the RFL4036 surface so that more broken fibre debris would be produced. It is suggested that the wear between RFL4036 and brass is dominated by abrasive particles of broken fibre and brass.
